Manhole Inspection Summary

Manhole # S35WW_001MH

Insp Date: **1/8/07 12:45 PM**

Location Address: **2947 CALVERT ST**

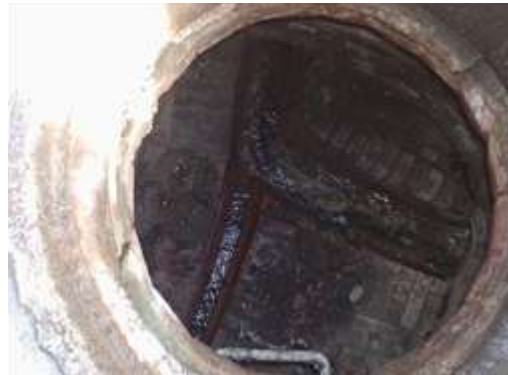
Top View

☒ **Debris** (not Condition related)

☒ **Evidence Of Surcharge**

Evidence of surcharge - Bench debris.
Channel debris.

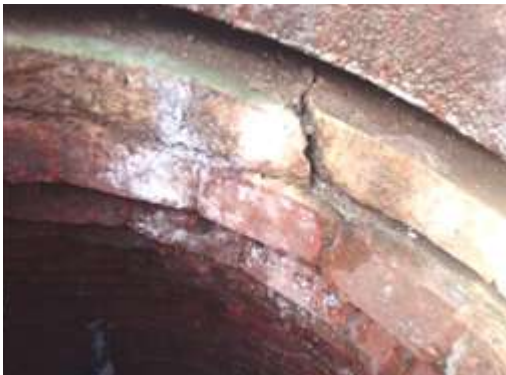
Defect

☒ **Cracked**

☒ **Deteriorated**

☒ **Joint**

☒ **Cracks**

Adjustment deterioration, cracks and
infiltration. Corbel infiltration.

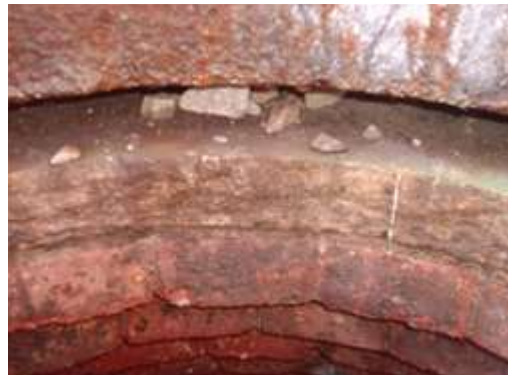
Defect

Adjustment deterioration and infiltration.

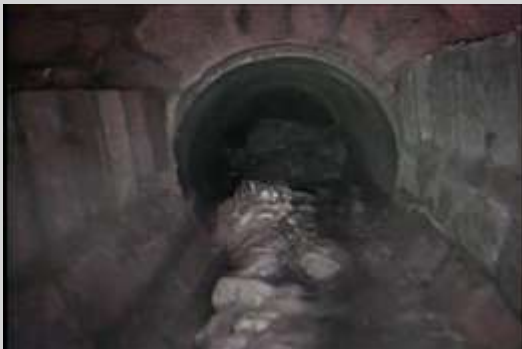
10 in. Circular Gravity Sewer Pipe In @ 3 O'Clock

Deposits: ☐ None ☐ **Mud** ☐ Sludge ☒ **Debris** ☐ Grease

Silt Depth: **3** (in.) Deposits Extent: **Light**

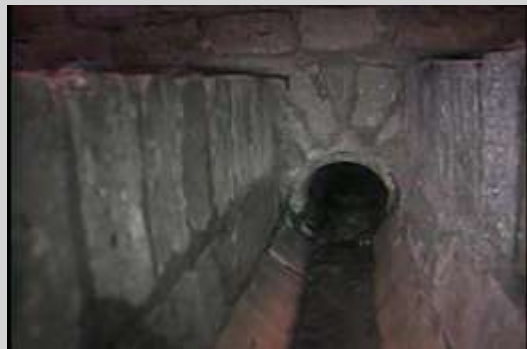
4 in. Circular Gravity Sewer

Deposits: ☐ None ☒ **Mud** ☐ Sludge ☒ **Debris** ☐ Grease

Silt Depth: **1** (in.) Deposits Extent: **Light**

Infiltration: **Evidence**
